My experiences with Sunbeam S8.

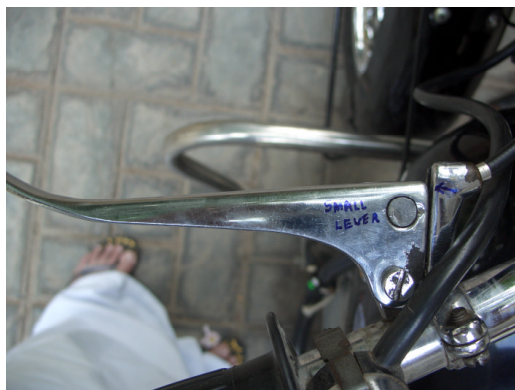
After completing assembly of the machine, I found by chance, the reason for the abnormal behavior of the clutch. I found that, the clutch lever as fitted to the machine was not an original part for this Sunbeam. The distance between the fulcrum and the hitching point of the Bowden wire were different between the front brake lever and the clutch lever. You may observe this in the pictures below.

Incorrect lever fitted originally when the machine was received.

With the lever replaced with a correct part, the clutch problem was resolved. This and similar problems are uncommon but if ever it happens it is also difficult to locate the problem.

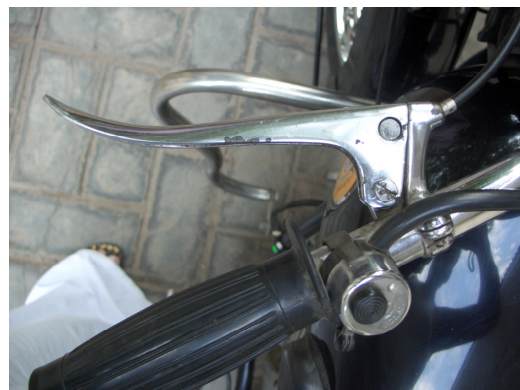
Correct clutch lever that I replaced the original with.

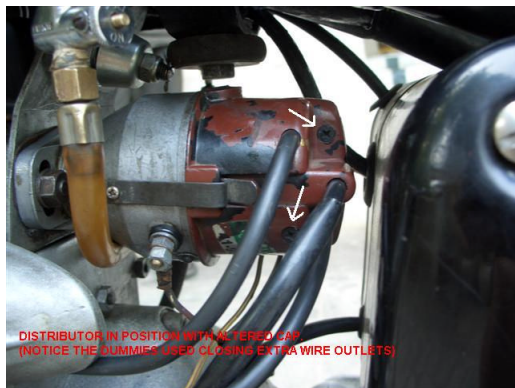
Distributor in position with altered cap.
(Notice the dummies used closing extra wire outlets)

I could locate a Lucas distributor cap of a four-cylinder car engine readily available in the market. The cap-locating peg on distributor body and two of the plug wire take off positions were matching with that of the original cap and so I decided to make use of this cap. I faced another minor problem here. The car distributor cap was higher than the original one and the distributor rotor wasn't touching the carbon inside the centre of the cap. The high voltage from the coil passes to the plug wires through this carbon only. Fortunately, there was enough material on the bottom side of the car distributor cap that I could turn it down and reduce the height.

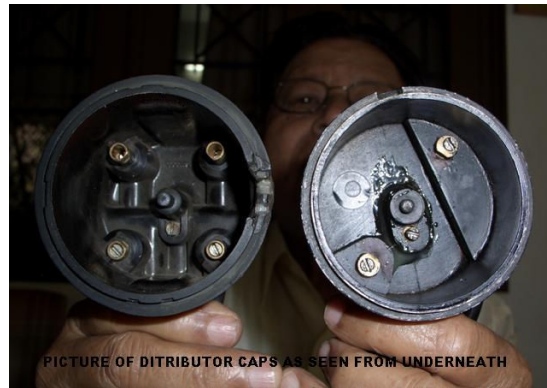
Picture of distributor caps as seen from underneath

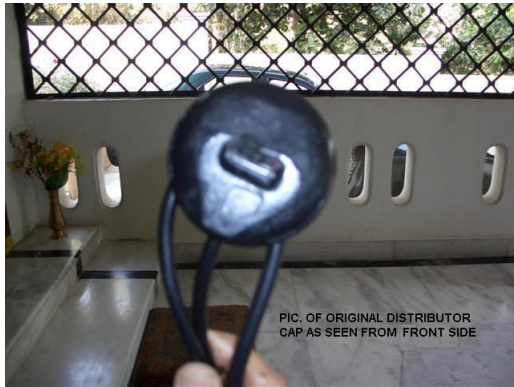
Picture of original distributor cap as seen from top side

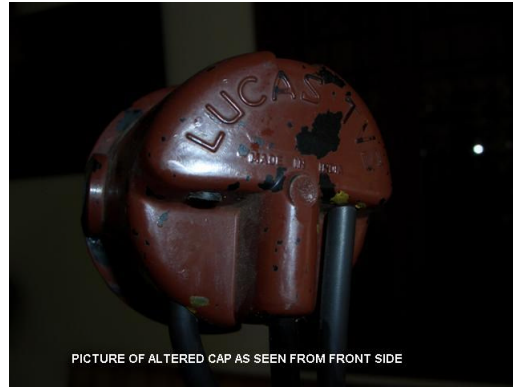
Picture of altered cap as seen from top side

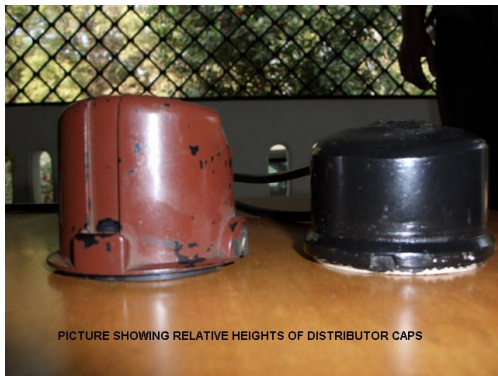
Picture showing relative heights of distributor caps

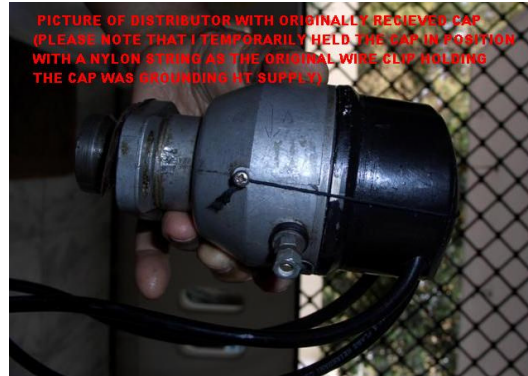
The next problem I faced was with ignition circuit. When the machine was delivered, it was not fitted with an original distributor cap. It had a hand made distributor cap and not of a good quality. In moist weather, I noticed high voltage passing from coil to plug wires through the distributor rotor was arcing between the distributor cap and wire clip holding the cap, as the wire clip is grounded through the distributor body and consequently the engine was missing. This used to become worse during rain. I provided insulation between the cap and the clip. This has reduced the problem but not cured it.

Picture of distributor with originally received cap. (Please note that I temporarily held the cap in position with a nylon string as the original wire clip holding the cap was grounding HT supply

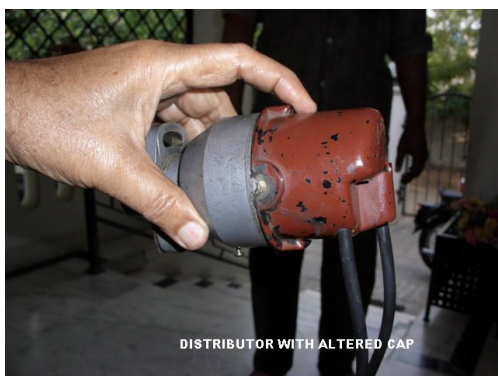
Distributor with altered cap

This alteration perfectly rectified the ignition problems. Later on, I installed a Rooster booster to improve the performance further and I found tremendous improvement on installation. The guidance provided by Martin Vincent of (Rooster Booster) "info@roosterignitions.com" was of immense help to me. Later on I purchased an "Ignition Coil 6 Volt Dual Output" from ignition@pazon.com to have a ready alternative and this made the ignition circuit perfect and foolproof. I could use the distributor cap or dual output coil. The system with distributor cap looks more original and with dual output coil, it was more reliable. In either cases I made use of the Rooster booster as it improves performance in both cases.

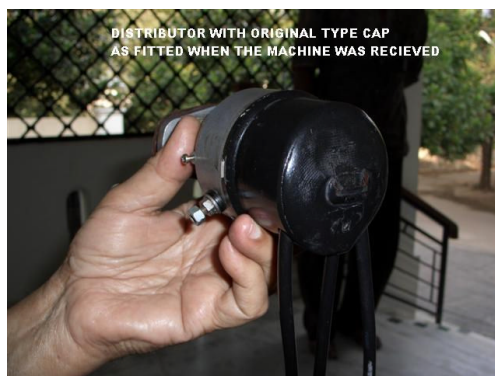
Distributor with original type cap as fitted when the machine was received

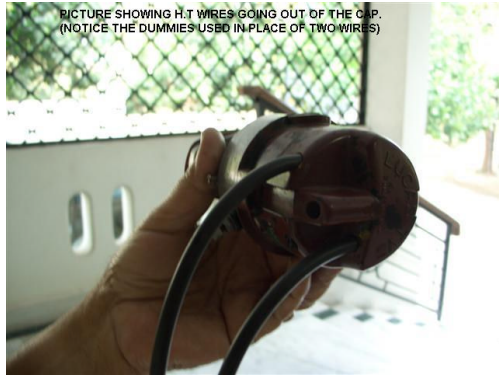
Notice the dummies used in place of two wires
